# EVALUATION OF DEEP-SEATED CRIB BLOCK FIRES AND DIRECT APPLICATION FIRE SUPPRESSION AGENTS

*Michael A. Trevits NIOSH, Pittsburgh, PA*

*John E. Urosek, MSHA, Pittsburgh, PA*

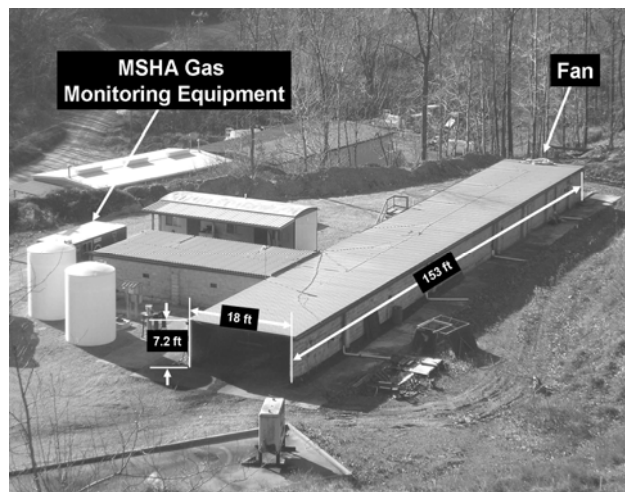
Figure 1. Fire Suppression Facility.

The FSF was configured to simulate a 150-ft long mine entry. The interior height of the simulated mine is 7.2 ft and the width is 18 ft. The roof of the simulated mine is made of corrugated steel bridge planks, the ribs are made of 8-in thick mortared solid concrete blocks and the floor is made of reinforced concrete. The interior roof is covered with a 2-in thick layer of Fendolite M-II ® (a specialized fire resistant mixture of vermiculite and Portland cement) and a 1-in thick layer of Fendolite M-II

® has been placed on the ribs.<sup>1</sup> For ventilation, a 6-ft diameter variable speed axivane fan (equipped with a pneumatic controller to adjust fan blade pitch) has been installed at one end of the simulated mine. The fan can provide blowing sustained airflow up to about 1150 fpm over the cross-section of the entry. Two doors, which permit access to the inside of the FSF, are located about 47 ft from the fan. Figure 1 shows the exterior of the FSF.

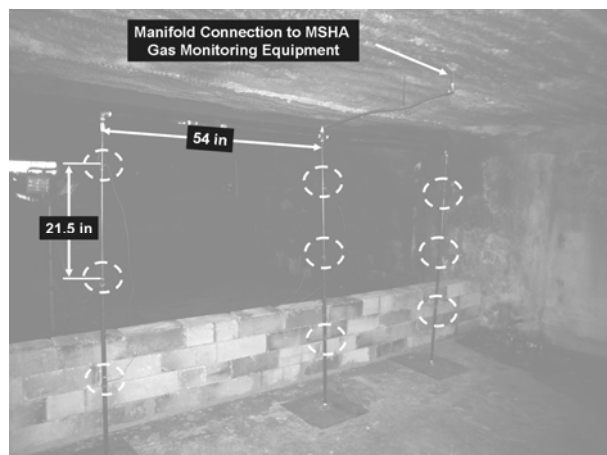
Figure 2. Layout of a gas monitoring array. (Circled areas show gas monitoring points and thermocouples).

The components of the fire gases were measured using three gas monitoring arrays. The first was a 9-point array located 21.2 ft from the trailing edge of the crib block sets. The array consisted of an interconnected network of ½-in diameter black iron pipe set across the width of the mine entry. A total of nine, 1/8-in diameter holes were drilled into vertical sections of the pipe to sample the fire gases. The holes in the pipe were spaced equally apart from the roof-to-floor and across the width of the entry (figure 2). A thermocouple was also positioned at each gas sampling point to measure the

temperature of the fire gases. The gases collected at each sample point were mixed together in a manifold that penetrated the FSF roof. The manifold was connected to a Tygon® tubing line that led to the MSHA Gas Monitoring Truck. The second gas sampling array was configured in the same manner as the first and was located 95.5 ft from the trailing edge of the crib block sets. The third gas sampling array was positioned near the second gas sampling array and consisted of 4, 1/8-in holes drilled into 1-in diameter black iron pipe (spaced equally from the roof-to-floor). The pipe was positioned vertically at the centerline of the entry and was connected to a line that led to a set of NIOSH infrared gas analyzers. The gas analyzers measured oxygen (O<sub>2</sub>), CO and CO<sub>2</sub> gas concentrations and the resultant data was collected at 10-second intervals and recorded by a computer-based data acquisition system.

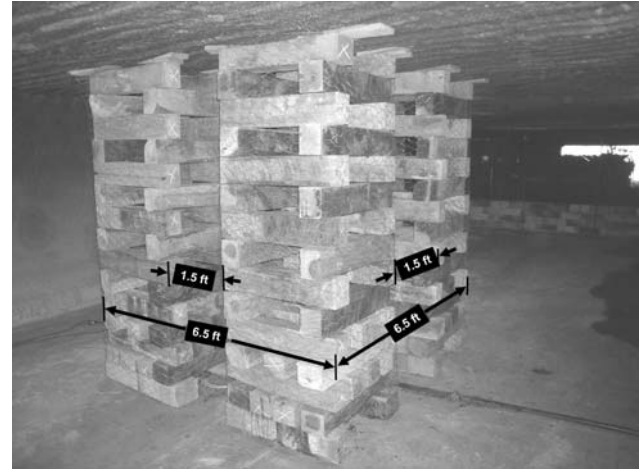
Figure 3. Typical crib block set-up prior to a test.

Table 2 provides information about the crib blocks used in this study. Each crib block set was constructed on foundation consisting of 8 solid concrete blocks (each block measured 6 in high, by 8 in wide by 16 in long). A total of 34 blocks were stacked vertically to build each crib set (17 of the older blocks and 17 of the newer blocks). Each row of blocks was oriented perpendicular to the adjacent row. The bottom row contained four blocks (two newer blocks on the outside and two older blocks on the inside) oriented with the 6-in side facing downward, the next row contained four blocks (two newer blocks on the inside and two older blocks on the outside) oriented with the 6-in side facing downward. The next row contained three blocks (two older blocks on the outside and one newer block on the inside) oriented with the 6-in side facing downward. The next row contained three blocks (two newer blocks on the outside and one older block on the inside) oriented with the 6-in side facing downward. The remaining rows contained two blocks each alternating between the new and older blocks in each row with the 5-in side facing downward. The final row of blocks was adjusted with the 5-or 6-in side facing downward depending on the relative closeness of the mine roof.

crib set, for the longest period of time, each crib set was wrapped with poultry fencing that was affixed to the wood with staples. Figure 3 shows the typical crib block set-up prior to a test.

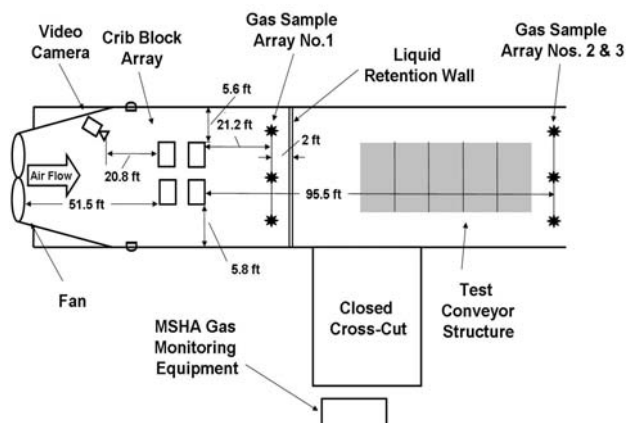
Figure 4. FSF typical set-up for a crib fire test.

The layout of the FSF for the crib block tests is shown in figure 4. The crib blocks were located 52 ft from the fan and 34 ft from a simulated conveyor structure in the FSF. The crib block sets were placed 1.5 ft apart and were positioned near the center of the entry. As mentioned previously, the crib block sets were constructed on solid concrete blocks and located in the middle of the blocks was an impinged natural gas burner that was equipped with 60 stainless steel jets (with a rated heat output of 44 to 114 kW). The burners were set on the simulated mine floor with the jets positioned about 2 in below first row of crib blocks. Natural gas was used instead of an accelerant (e.g. diesel fuel) to assist in starting the fires because it was more readily consumed by the fire and left no residue that could have altered the wood fire combustion products. A series of preliminary experiments showed that the natural gas burners would need to operate for about 50 minutes to ensure that the crib fires would burn without the need to re-light the burners.

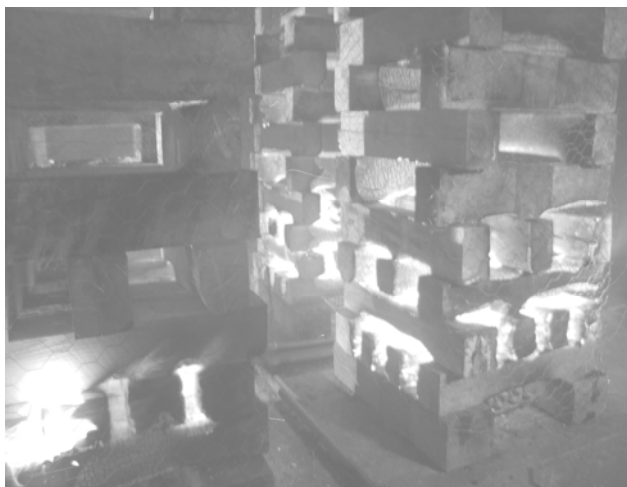
Figure 5. Control test - Burning crib block sets.

During test No. 1, after the gas supply was turned off, it was observed that the back set of blocks were burning more intensely than the front set of blocks most likely because they were sheltered from the ventilation air flow

by the front set of crib blocks. Although the fire grew vertically through each crib block set, the ventilation air currents caused the fire to burn more intensely towards the back side (downwind side) of each crib block set (figure 5). It was determined that this burning condition would most likely cause the crib sets to topple over rather than collapse vertically. The fire burned unremarkably until 94 minutes into the test when the rear left crib block set fell down. About 18 minutes later (112 minutes into the test) the rear right crib block set fell down. About 30 minutes later (142 minutes into the test) the front left crib block set fell down into the debris of the left rear crib block set and about 20 minutes later (162 minutes into the test) the front right crib block set fell down into the debris of the rear right crib block set. Each time a crib block set fell, the intensity of the fire increased for a short period of time.

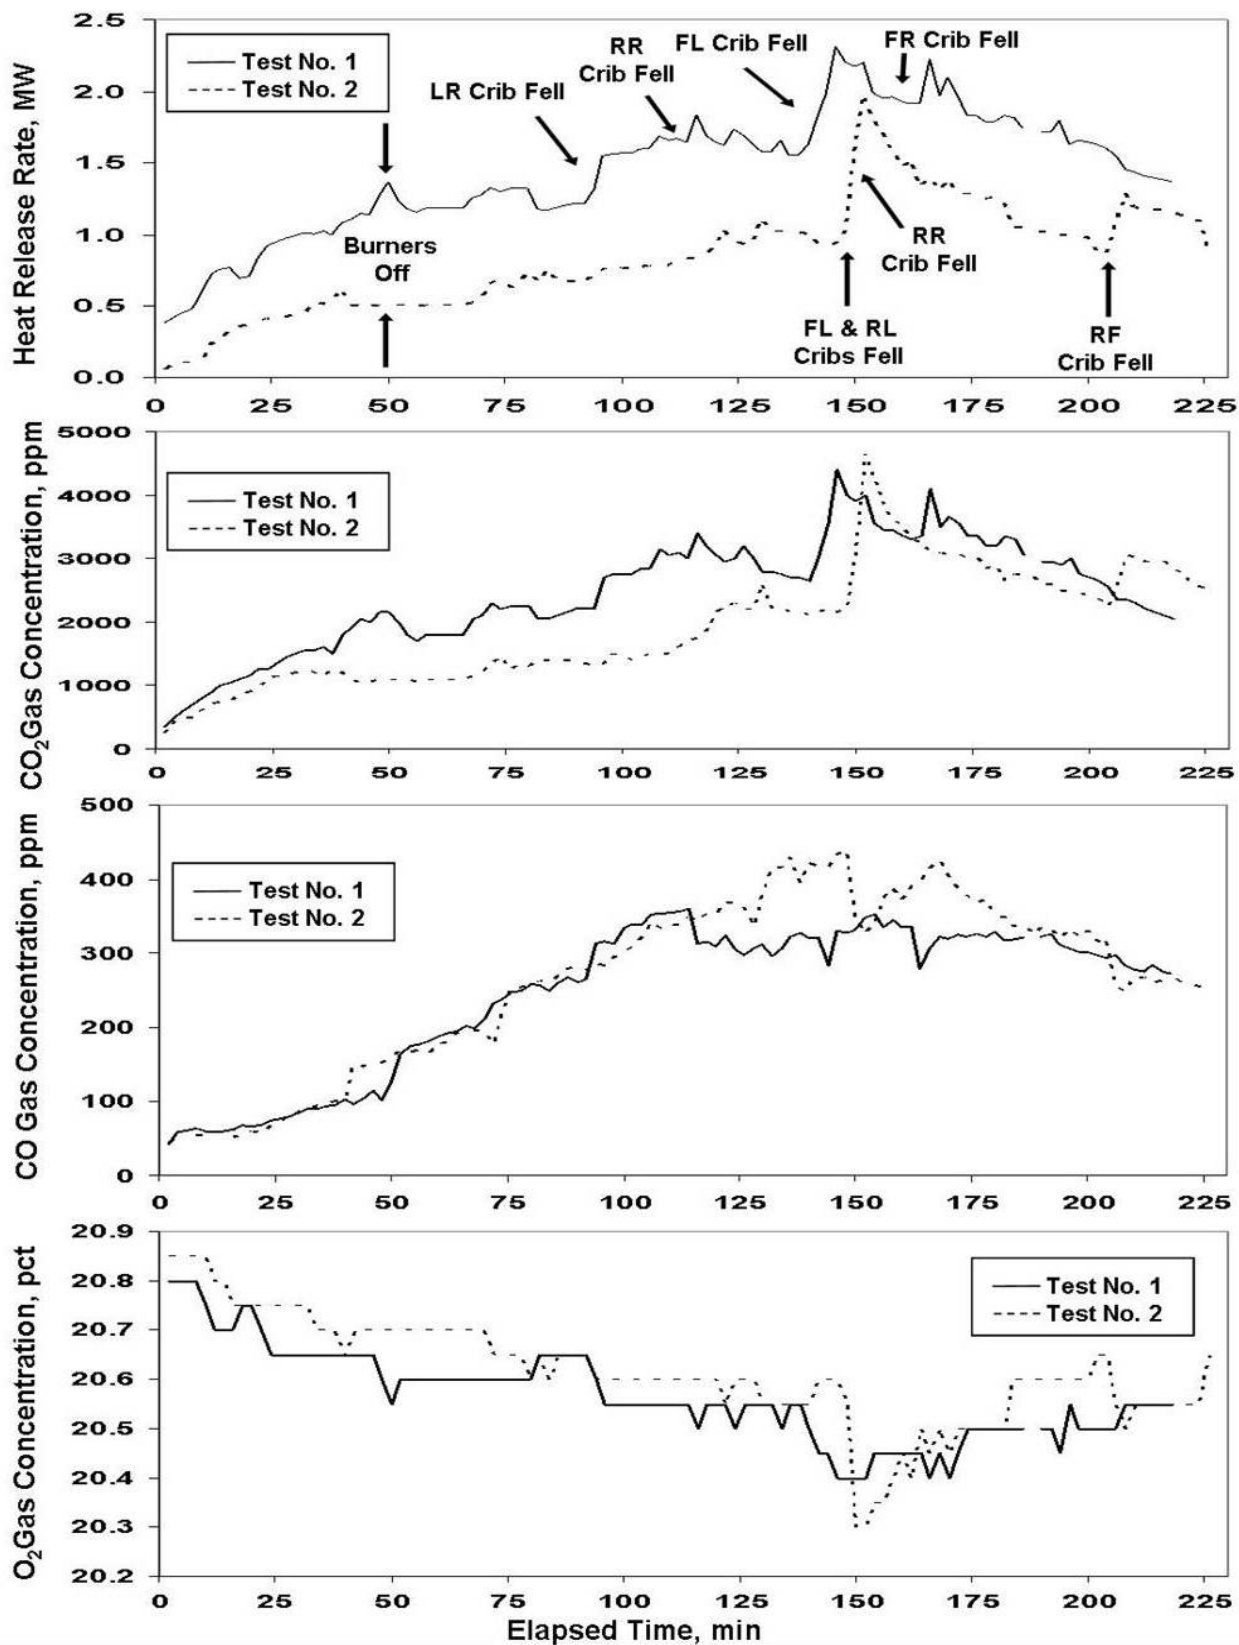
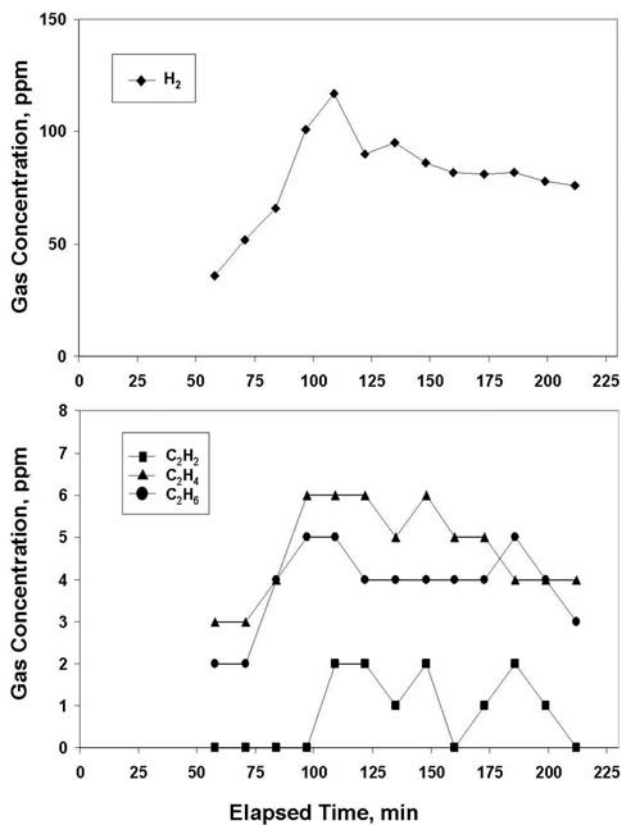
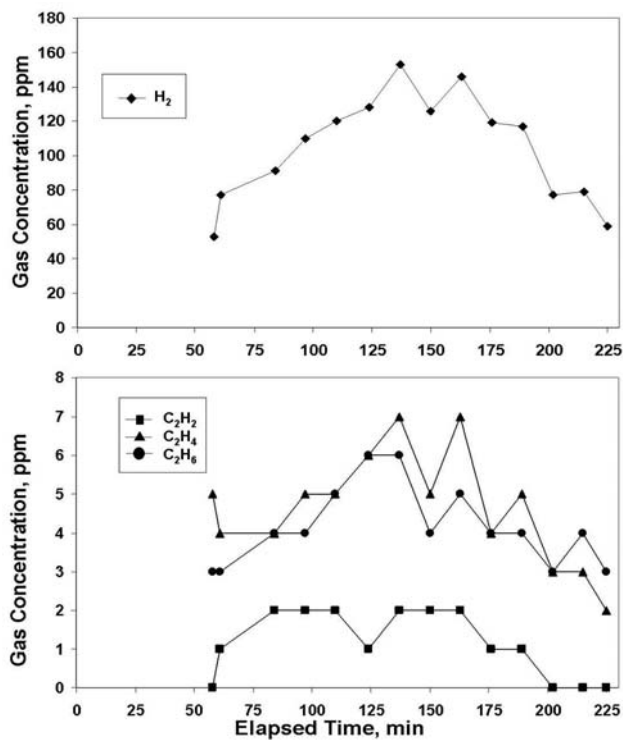
Figure 6A. Plot of estimated heat release rate and products of combustion for crib block tests Nos. 1 and 2.

Figure 6B. Gas chromatograph data for test No. 1.

Figure 6C. Gas chromatograph data for test No. 2.

A plot of the estimated heat release rate and the products of combustion for both tests are shown in figure Nos. 6A-C. From the figures, it appears that test No. 1 emitted a larger amount of heat and produced a larger amount of  $\text{CO}_2$  and less CO suggesting more complete combustion of the crib blocks than in test No. 2. Also, the gas chromatograph data (figure 6C) shows that  $\text{H}_2$ ,  $\text{C}_2\text{H}_2$ ,  $\text{C}_2\text{H}_4$  and  $\text{C}_2\text{H}_6$  gases was observed in the combustion product air stream during both tests and these gases are most likely the products of incomplete combustion and pyrolysis of the wood. During test No. 1, the concentration of hydrogen and the hydrocarbon gases appeared to follow the general trend of the CO gas concentration. This same relationship was observed in the  $\text{H}_2$ ,  $\text{C}_2\text{H}_2$ ,  $\text{C}_2\text{H}_4$  and  $\text{C}_2\text{H}_6$  gas concentrations measured during test No. 2.

Each time a crib block set fell, the geometry of the wood changed and the fire burned more intensely for a period of time. The change in the intensity of the fire is reflected as an increase in the estimated heat release rate immediately following one of these events along with the associated increase in the products of combustion. The increase in fire intensity is most likely due to the close proximity of the fallen burning crib blocks and the associated heat build-up.

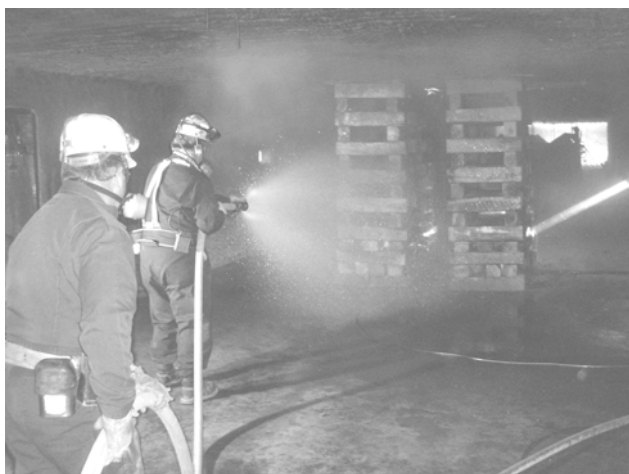
Figure 7. Use of fire hose during crib block fire test No. 3.

The individuals selected to apply the water to the fire were NIOSH technicians who had previously served as coal miners and had training and experience in the use of a fire hose. The technicians were instructed to apply the water until they observed that the fire had been extinguished. For personal safety reasons, the technicians were also instructed not to progress past a line that had been drawn on the entry floor (perpendicular to the trend of the entry) about 18 in upwind from the leading edge of the crib block sets. This location was selected because it would keep the technicians out of the smoke and away from the heat of the fire. Water was applied to the fire for about 4 minutes when the technicians decided the fire had been extinguished and a total of 300 gallons of water was used (figure 7). Observations of the wood showed that the horizontal surfaces appeared to be wet and water was observed to be actively dripping from the vertical surfaces. About 4 minutes after the water application was completed, hot spots (glowing embers) were observed in the rear left and rear right crib block sets. At about 52 minutes after the water application was stopped, small flames were observed in the rear left crib block set. The embers and flames eventually self-extinguished and no other events were observed.

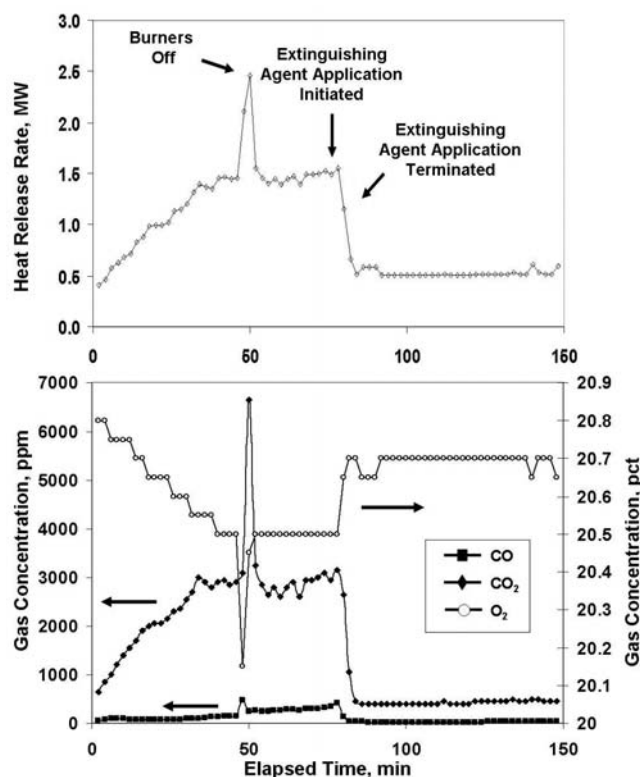
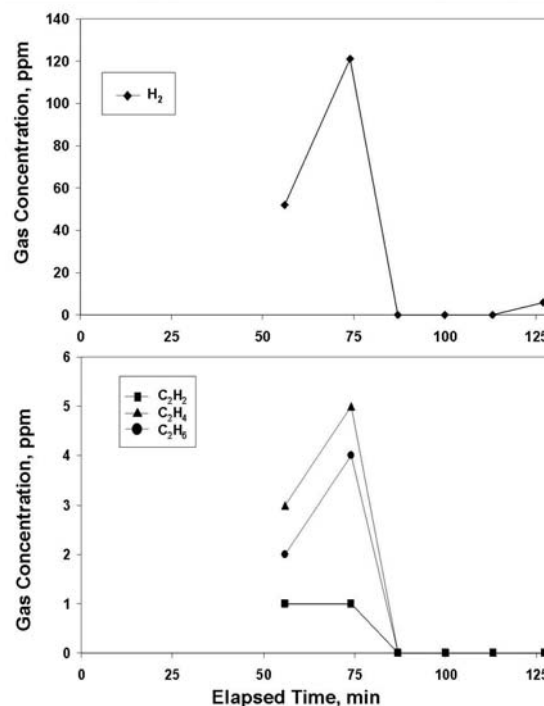
Figure 8A. Plot of estimated heat release rate and products of combustion for crib block test No.3.

Figure 8B. Gas chromatograph data for test No. 3.

Figure Nos. 8A-B shows plots of the estimated heat release rate and the products of combustion for this test. As observed in the control tests, the fire showed an increase in heat output and  $CO_2$  production during the intense burning event or when the crib block sets shifted or fell.  $CO$  production increased at a steady rate with only slight changes when the fire intensified or when the crib block set shifted or fell. As expected, the heat output of the fire and the production of combustion gases declined dramatically as the water was applied (refer to

figure Nos. 8A-B). As observed in the controls tests, the fire also produced  $H_2$ ,  $C_2H_2$ ,  $C_2H_4$  and  $C_2H_6$  gases which are considered to be the products of incomplete combustion and pyrolysis of the wood. Unfortunately, because this test was of a short duration and only a very limited set of gas chromatograph data was collected during this test, it is therefore difficult to make comparisons with the other gas species.

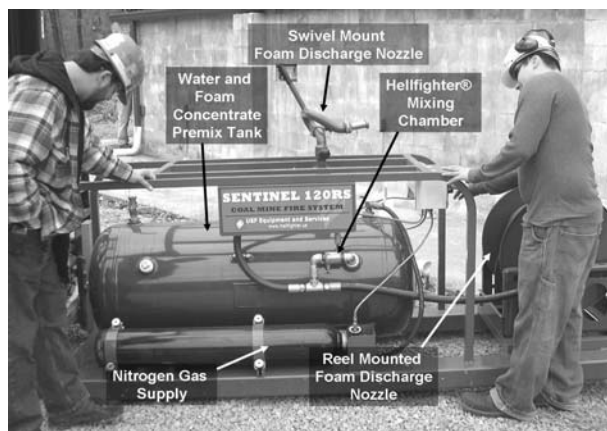
Figure 9. USF Sentinel® unit used during crib block fire test No. 4.

The system used was a Sentinel 120RS unit supplied by USF Equipment and Services (a research partner in this test). The Sentinel 120RS is a self-contained fire fighting system that uses the patented Hellfighter® mixing chamber to create foam [10]. The system used was capable of producing 2,400 gallons of gas enhanced foam using a mixture of water, a small amount of Mine Fire Fighting Foam® (MFFF) concentrate and nitrogen

gas (figure 9). The system can discharge up to 300 gpm of gas-enhanced foam. Prior to the entry into the FSF, the NIOSH technicians were instructed on the proper use of the Sentinel unit and application of the foam product on the fire. As in the previous test, the technicians were instructed to apply the gas-enhanced foam until they observed that the fire had been extinguished.

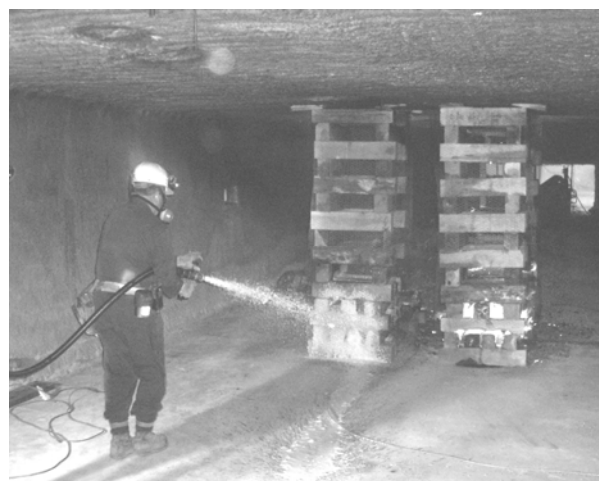
Figure 10. Use of gas-enhanced foam during crib block fire test No. 4.

Gas-enhanced foam application began 103 minutes into the test and about 1 minute later, the right rear crib block set fell down (figure 10). Foam application continued for about 8 minutes when the technicians decided that the fire had been extinguished. A total of 2,400 gals of gas-enhanced foam (the entire capacity of the system) was used. At about 40 minutes after the foam application had been completed, the foam had degraded to the point where it was no longer observed on the vertical

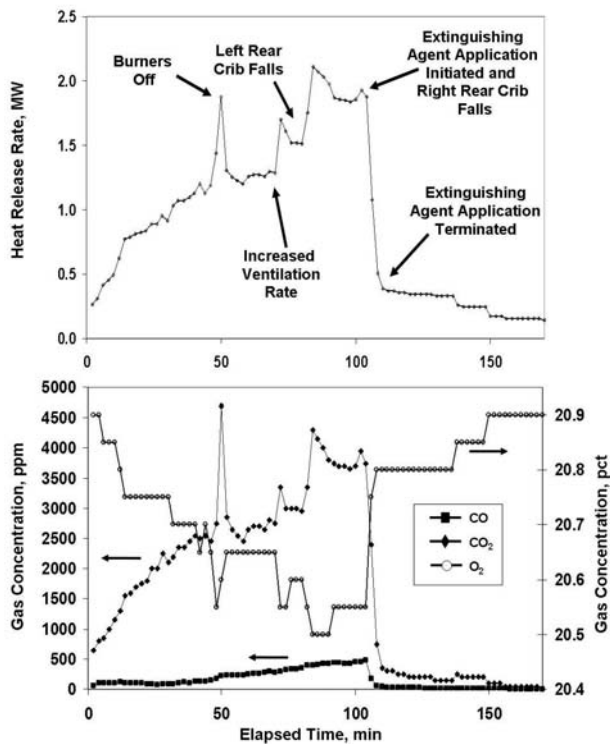
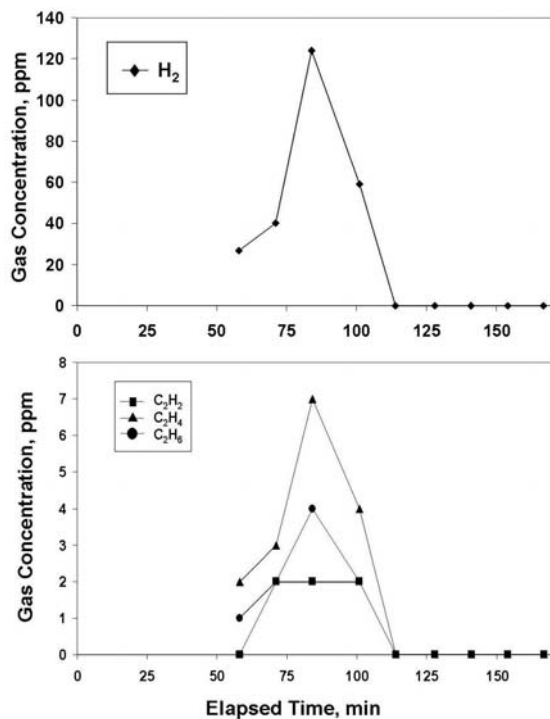
Figure 11A. Plot of estimated heat release rate and products of combustion for crib block test No.4.

Figure 11B. Gas chromatograph data for test No. 4.

Figure Nos.11A-B shows plots of the estimated heat release rate and the products of combustion for this test. As observed in the previous tests, the fire showed an increase in heat output and CO<sub>2</sub> production during the intense burning event or when a crib block set fell. CO production increased at a steady rate with only slight changes when the fire intensified or when the crib block set fell. The heat output of the fire and the production of combustion gases declined dramatically when the foam extinguishing agent was applied (refer to figure Nos. 11A-B). As in the previous tests, the fire produced H<sub>2</sub>, C<sub>2</sub>H<sub>2</sub>, C<sub>2</sub>H<sub>4</sub> and C<sub>2</sub>H<sub>6</sub> gases. The change in concentration of these gases appeared to follow the same general trend of the CO<sub>2</sub> gas concentration.

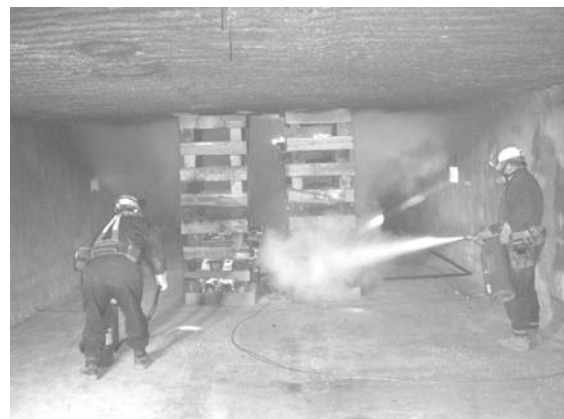
Figure 12. Use of fire extinguishers during crib block fire test No. 5.

ABC-rated fire extinguishers contain monoammonium phosphate and/or ammonium sulphate powder that leaves a non-flammable layer of material (which melts at a low temperature) and blocks gas and heat transfer at the fuel surface. For this test, four, 30-lb fire extinguishers were placed in the FSF upwind of the crib block sets. To ensure that the extinguishers were in proper working order, they were filled with ABC powder and were outfitted with new CO<sub>2</sub> cartridges the day before the test.

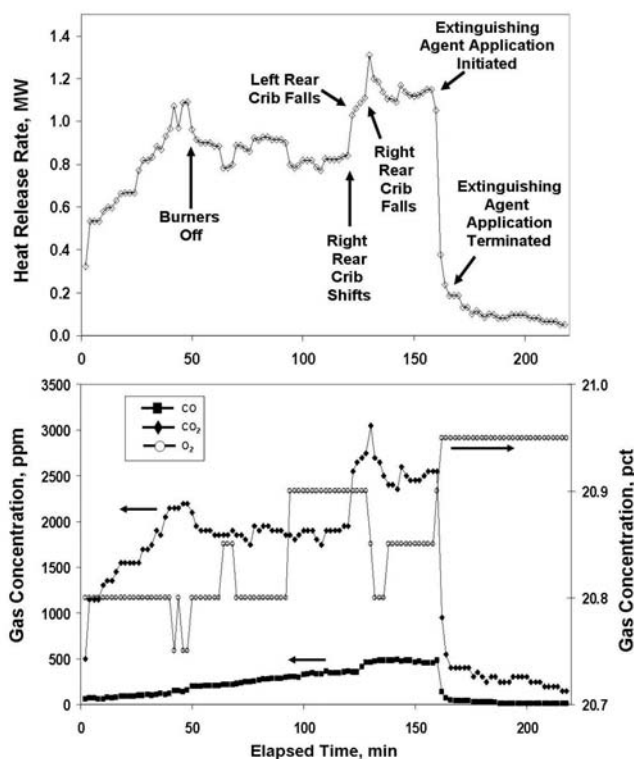
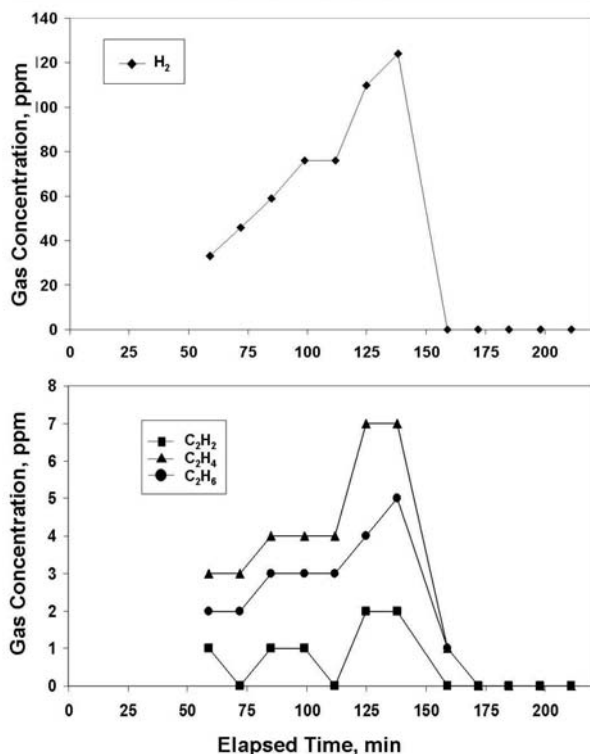
Figure 13A. Plot of estimated heat release rate and products of combustion for crib block test No.5.

Figure 13B. Gas chromatograph data for test No. 5.

As shown in figure No. 13A, the increase in heat output of the fire and CO<sub>2</sub> production was related to the changing geometry of the wood pile as a crib block set fell. CO production increased at a steady rate with only slight changes when the fire intensified or when the crib block set fell. The heat output of the fire and the production of combustion gases declined dramatically as the extinguishing agent was applied. As in the previous tests, the fire produced H<sub>2</sub>, C<sub>2</sub>H<sub>2</sub>, C<sub>2</sub>H<sub>4</sub> and C<sub>2</sub>H<sub>6</sub> gases (refer to figure 13B). The change in concentration of these gases appeared to follow the same general trend as the CO<sub>2</sub> and CO gas concentrations.
